BAKER (MICHAEL) JR INC BEAVER PA
NATIONAL DAM SAFETY PROGRAM. CARROLL DAM (STONY CREEK NUMBER 10--ETC(U)
AUG 78 M BAKER

Name Of Dam: CARROLL (STONY CREEK NO. 10)
Location: SHENANDOAH COUNTY, STATE OF VIRGINIA
Inventory Number: VA 17102

LEVEL II
PHASE I INSPECTION REPORT
NATIONAL DAM SAFETY PROGRAM

Name of Dam: Carroll
State: Virginia
County: Shenandoah
Stream: Alum Run, Tributary to Stony Creek
Date of Inspection: 2 June 1978

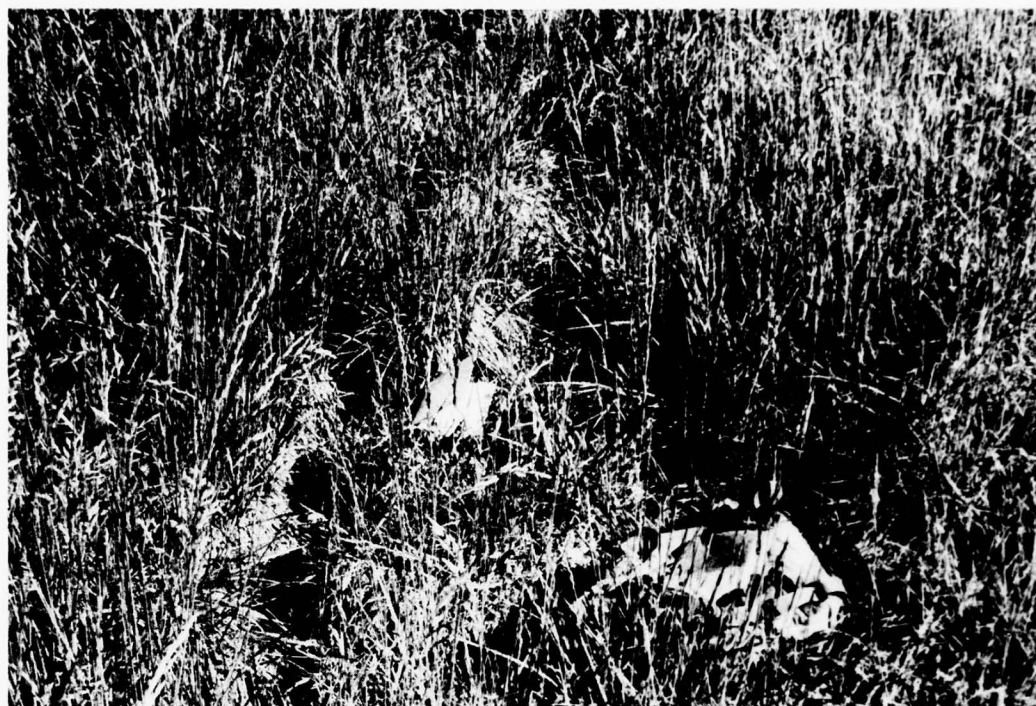
PHOTO 1

3.1.2 Dam: A twelve inch by six inch deep erosion gully was observed at the contact of the downstream embankment slope with the left abutment. A heavy growth of grass surrounded the gully which was about 30 feet in length. Additional measures will be needed to arrest the erosion. The channel is shown in Photo 1 of Appendix II.

It is recommended that stability analyses be performed using the as-built embankment section. The minor erosion on the downstream slope of the embankment and on the left slope of the emergency spillway should be repaired as part of the annual maintenance program of the Lord Fairfax Soil and Water Conservation District. The primary spillway riser should also be cleaned of trash and debris.

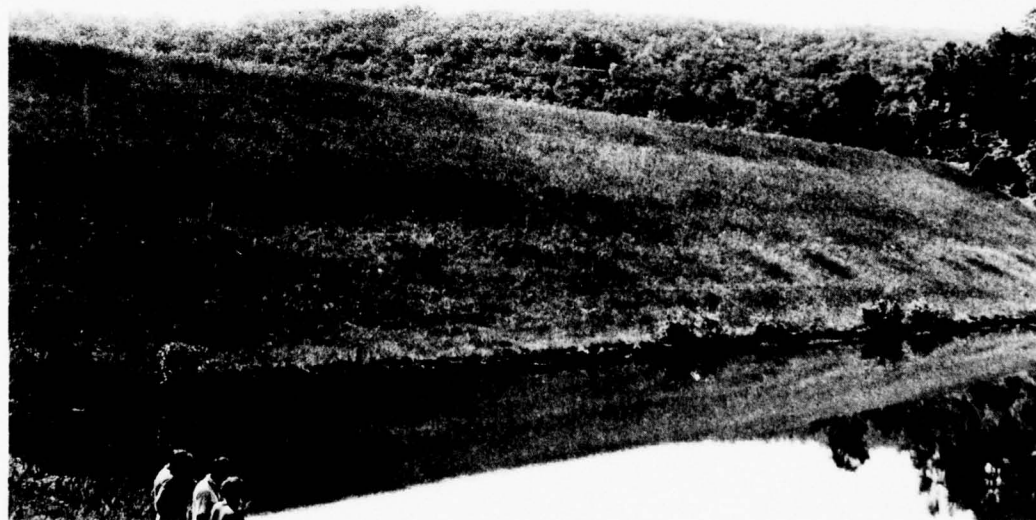
PHOTO 2

A one foot high wave cut bench was observed on the upstream slope at normal pool elevation and is visible in Photo 2. The wave erosion did not appear to be progressive; and considering the large distance between the dam crest and normal pool (43.6 feet), riprap protection does not appear to be necessary. Upstream slope protection should be considered, if wave erosion does increase.
